Port of Astoria Pier 2
Results of Inspection 9/2015 & 1/2016, 9/2016

Port of Astoria Pier 2
 Results of Inspection 9/2015 & 1/2016

BEGIN BRIDGE 22452

Port of Astoria Pier 2
 Results of Inspection 9/2015 & 1/2016
 Structure #22526

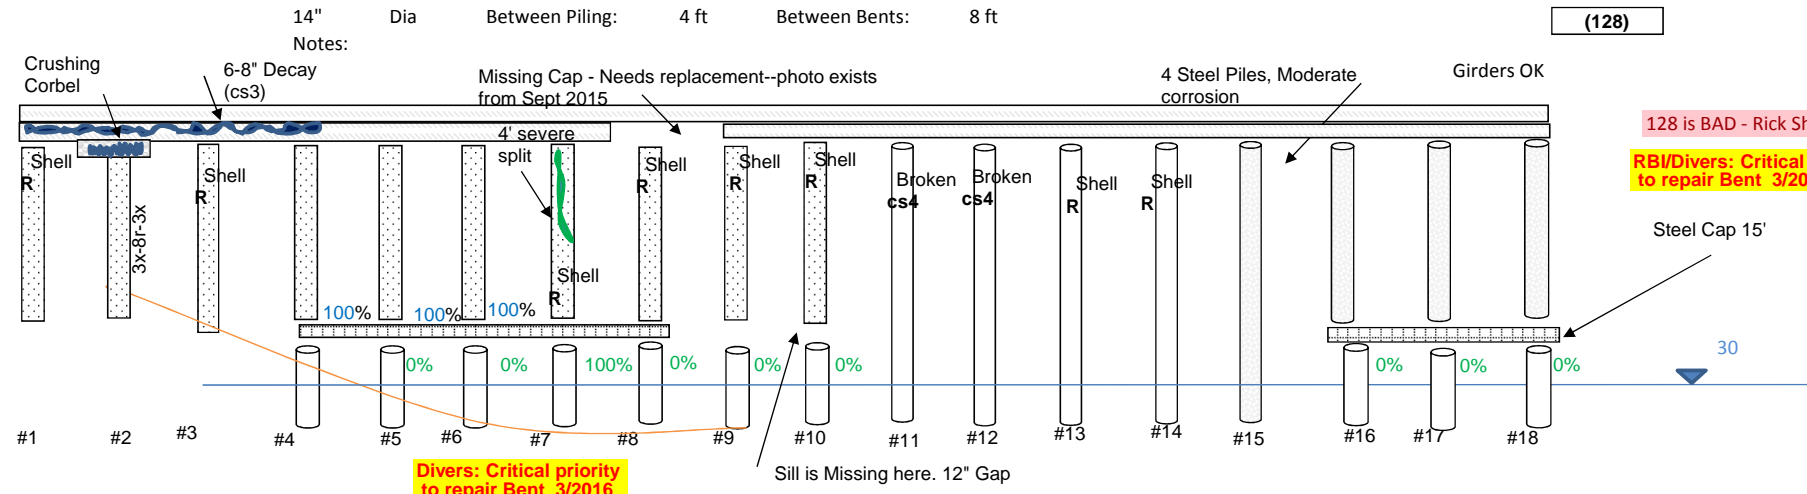
128 is BAD - Rick Shorb

RBI/Divers: Critical priority to repair Bent 3/2016

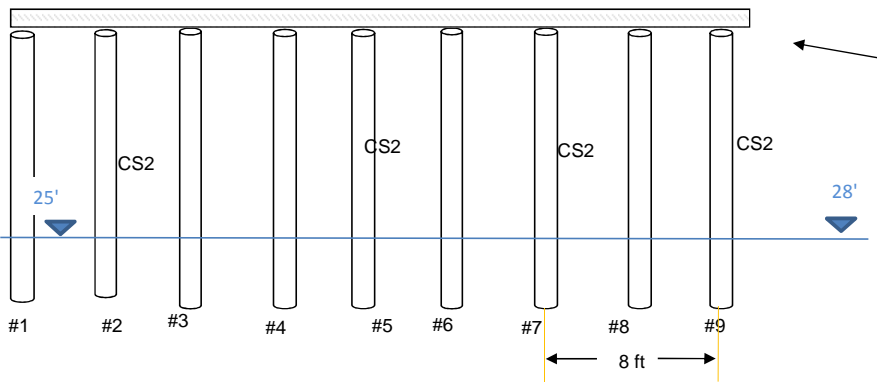
Overhang/
missing piles

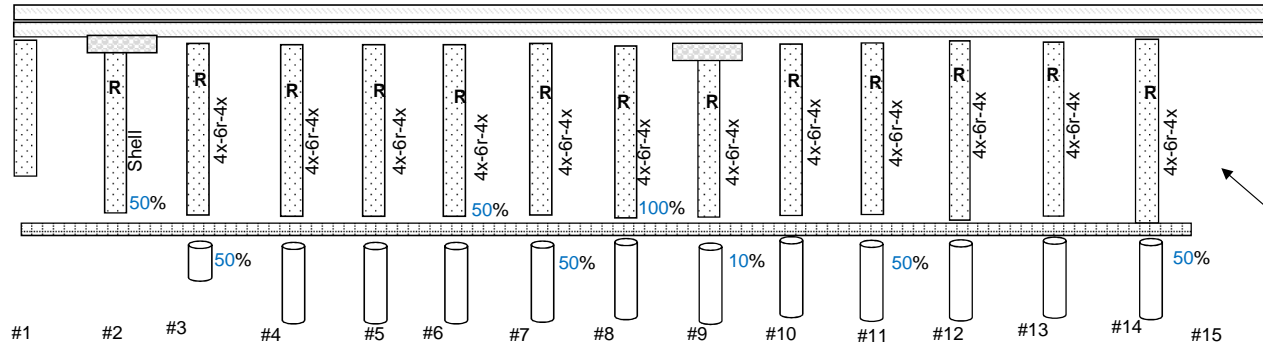
Bent 213

Missing pile & column

RBI: Urgent priority to repair Bent 3/2016
