Port of Astoria Pier 2
Results of Inspection 9/2015 & 1/2016, 9/2016

Port of Astoria Pier 2
 Results of Inspection 9/2015 & 1/2016

BEGIN BRIDGE 22452

Port of Astoria Pier 2
 Results of Inspection 9/2015 & 1/2016
 Structure #22526

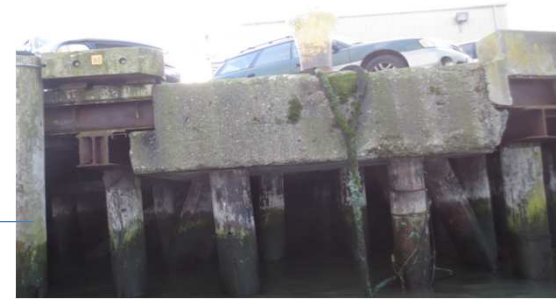
(157)

16" Dia Between Piling: 4 ft Between Bents: 10 ft
Notes:

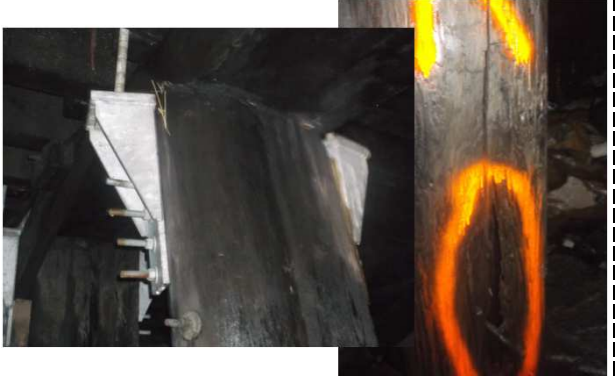
(158)

158 & 161 share a first corbel and it is CS4 - included on 161

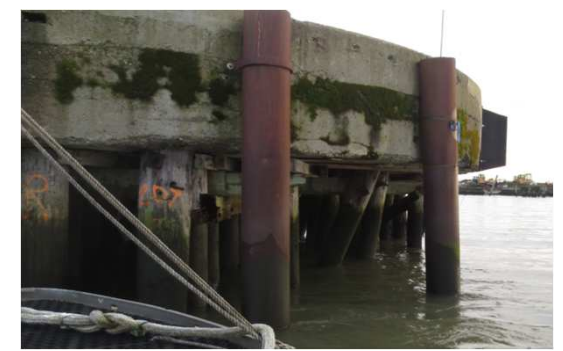
Overhang/
missing piles
